LESER Global Standard

Final visual inspection of repaired valves

LGS 4117

This LESER Global Standard (LGS) provides instruction on the visual final inspection of LESER safety valves. The required work steps and materials are described.

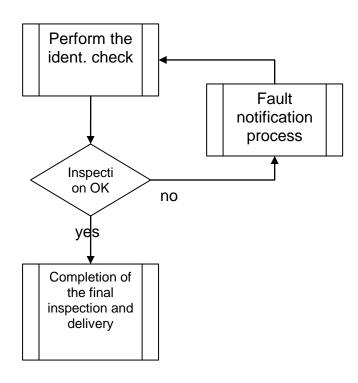
Figure 6-1

6 Flow chart for the visual inspection (final inspection)

If the result of the inspection is okay, then the safety valve is sent for packaging and shipment.

- If the result of the inspection is not okay, then the fitting is sent to the fault notification process that is to be determined.
- The final inspection is performed again after completion of the fault notification process.

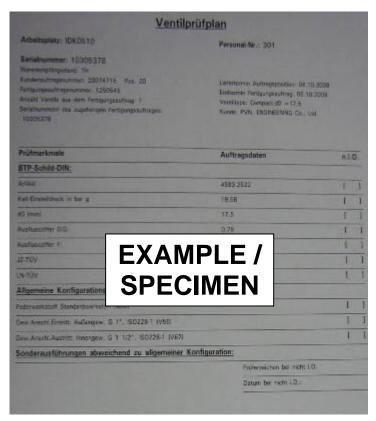
Figure 7.1-1

a) Compare the content of the valve inspection plan or repair order to the valve model.

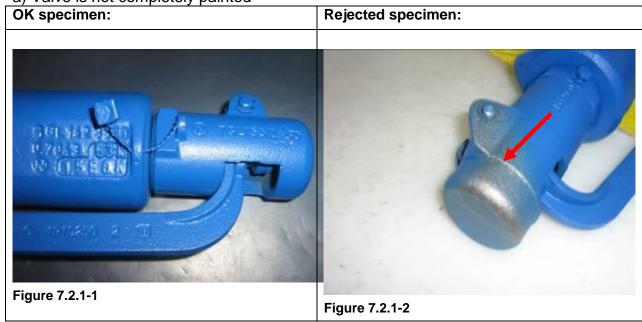
a) Valve is not completely painted

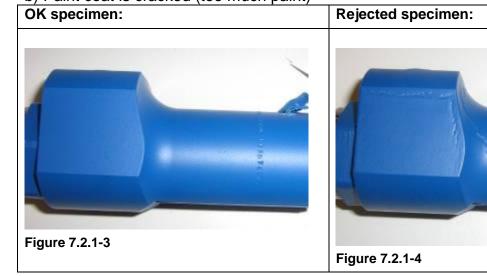
b) Paint coat is cracked (too much paint)

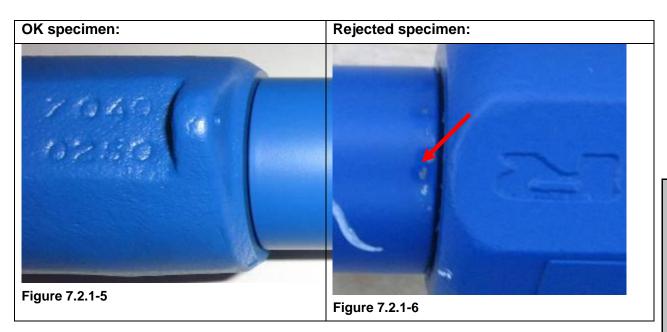
c) Paint coat is not complete due to oil / grease

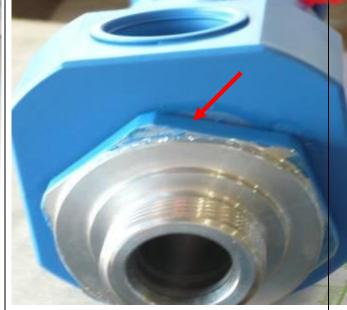
Rejected specimen:

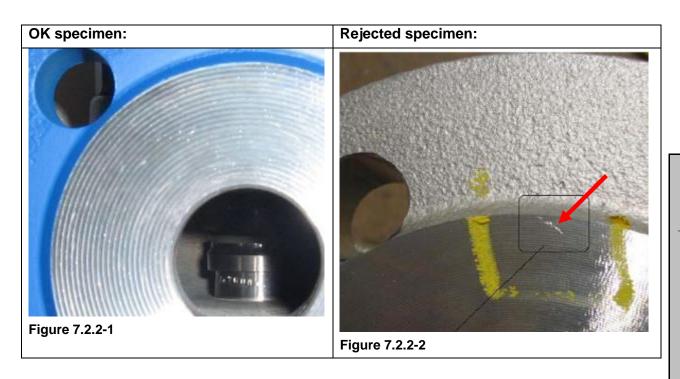
7.2.2 Inspection of the sealing surfaces

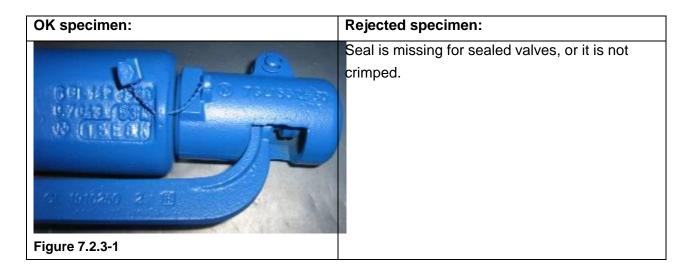
7.2.3 Inspection of the seal
